# Manhole Inspection Summary

Manhole # S31GG\_038MH

Insp Date: 1/23/07 11:05 AM

**Location** Address: **JOHN ST**

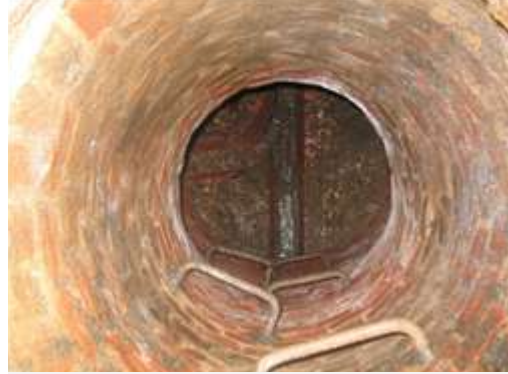
Top View

Evidence of surcharge - Bench debris.  
Channel debris.

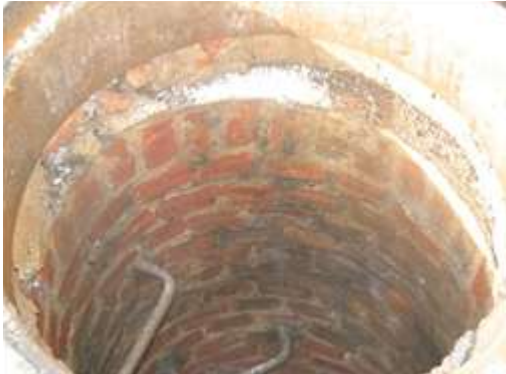
Defect

Frame leaks. Frame offset. Adjustment deterioration and infiltration. Corbel and Barrel infiltration - other side.

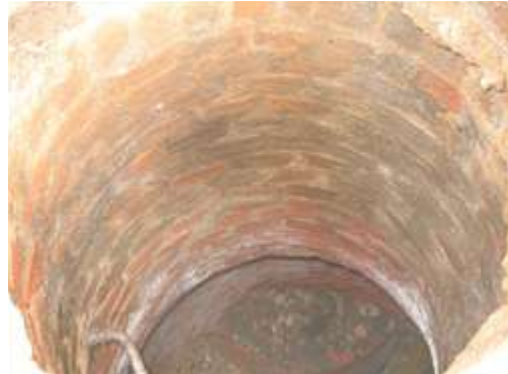
Defect

Frame leaks. Adjustment deterioration and infiltration. Corbel and Barrel infiltration.

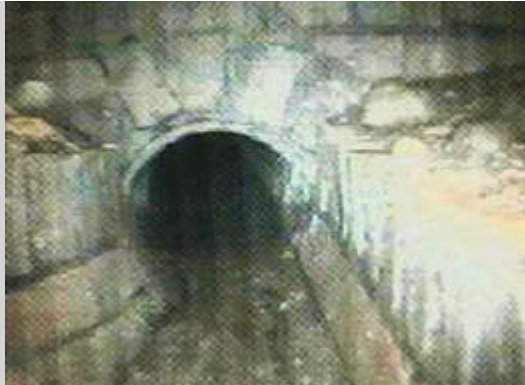
### 8 in. Circular Gravity Sewer Pipe Out @ 12 O'Clock

Deposits: ☐ None ☒ **Mud** ☐ Sludge ☐ Debris ☒ **Grease**

Silt Depth: **0** (in.) Deposits Extent: **Light**

Infiltration: **Evidence** Pipe Seal Cond: **Cracked**

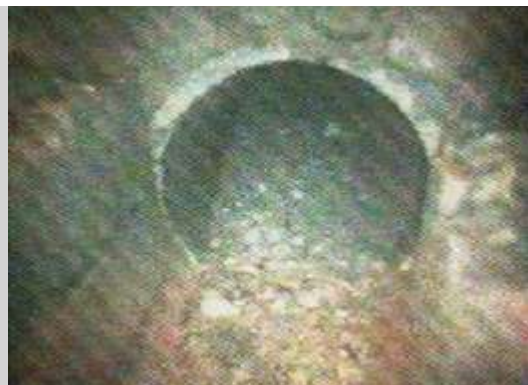
Pipe In @ 9 O'Clock

Service line - plugged?

Infiltration: **Evidence**

Connects To: **Stub connection / abandoned**
